# Make Data Driven, Continuous Efficiency Improvements as Standard Practice:

## Technical Loop

**Convenience Store Chain Seeks to Substantially Reduce Energy Use in Fleet**  
*EEB Hub Seeks to Establish CEI Loop Paradigm for All Such Energy Intensive Fleets*

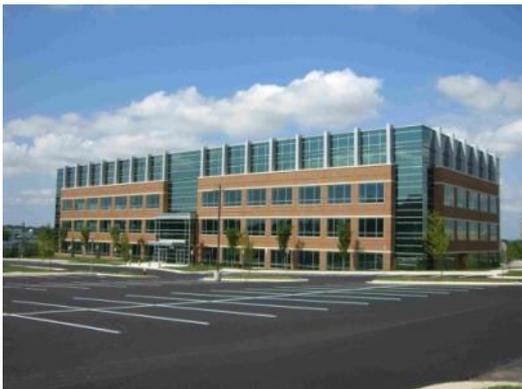
**A local Office Building**

- 101,700 ft<sup>2</sup>
- 2,175,880 kWh/year
- 0 therms/year
- 73 kBtu/(ft<sup>2</sup>-year)

**A typical Philadelphia Convenience Store**

- 5,589 ft<sup>2</sup>
- 648,080 kWh/year
- 1,351 therms/year
- 420 kBtu/(ft<sup>2</sup>-year)

**600 "Full Service Convenience Stores = 3,500 Mid-Sized (35- 40,000 ft<sup>2</sup> ) Office Buildings**

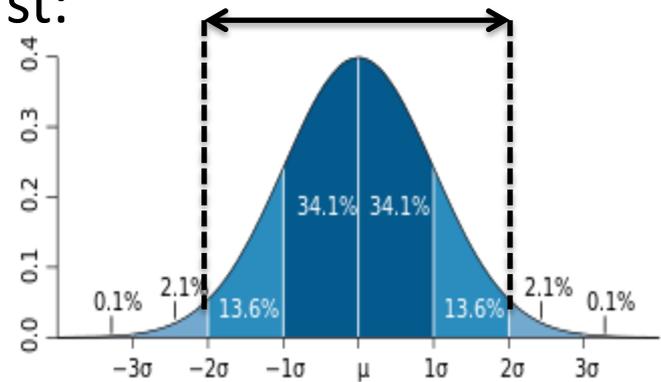
- Excessive Energy ? Check outliers first:
  - Incorrect metering
  - Malfunctioning equipment
- 95% Confidence Interval:
  - Fuel Stores: 305 – 549 kBtu/ft<sup>2</sup>-yr
  - Non-Fuel Stores: 305 – 545 kBtu/ft<sup>2</sup>-yr

A plot of a normal distribution where each band has a width of 1 standard deviation.

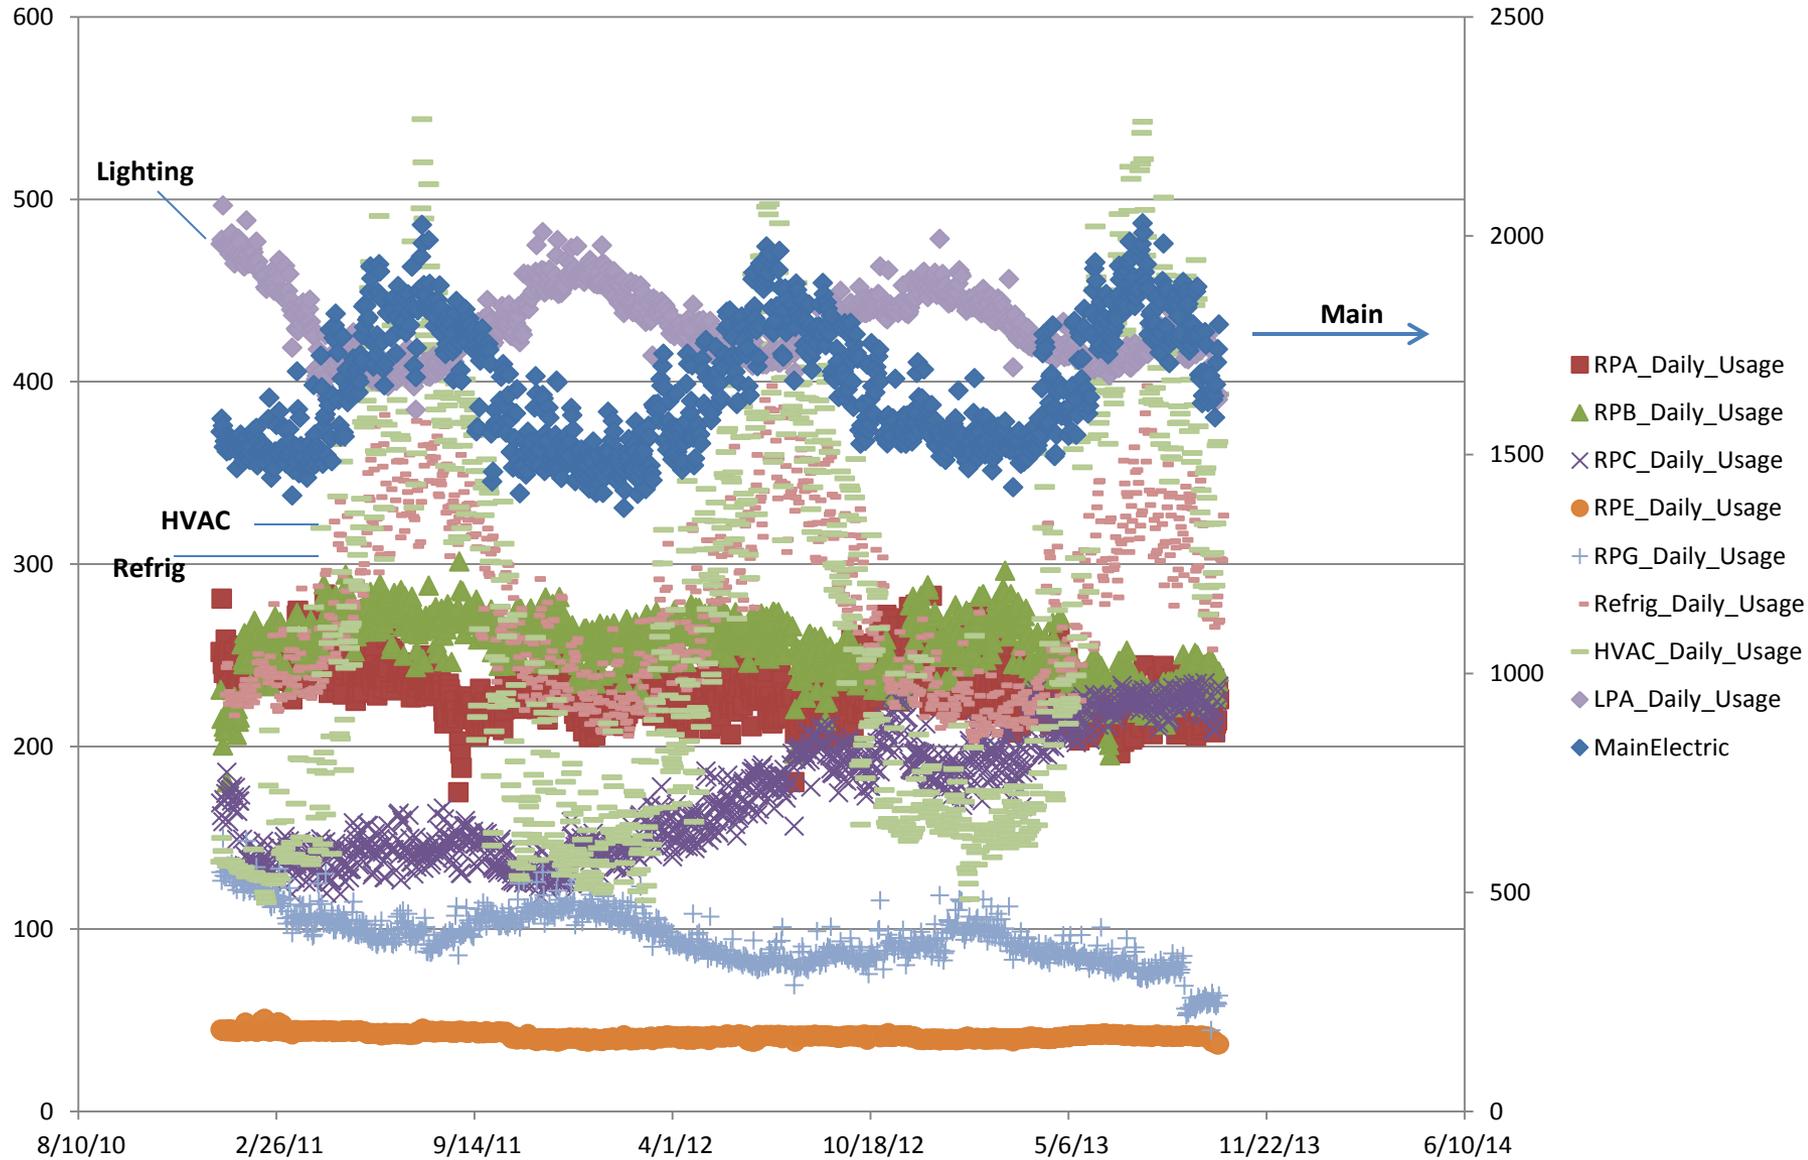
# Store 592 Energy Utilization Data

Kwhr (Sub Panels)

Kwhr (Main Feed)

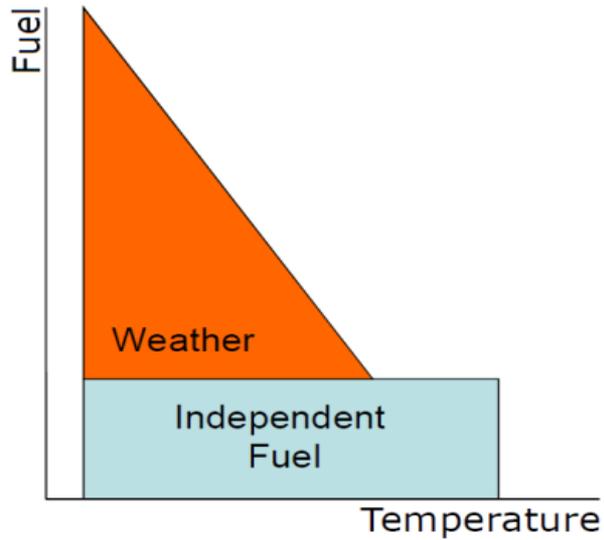
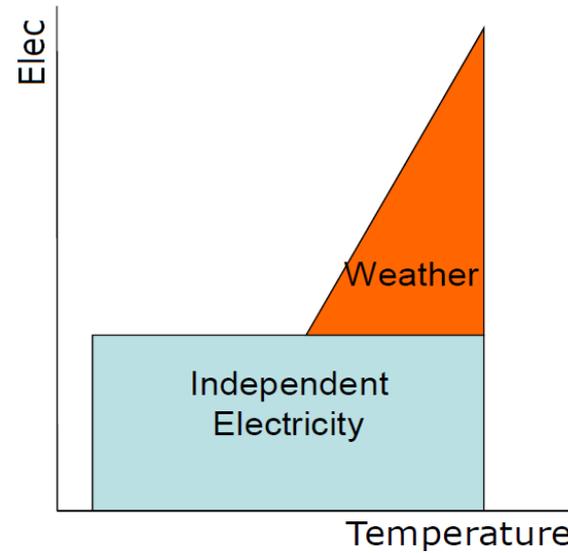
Weather/Non weather dependent energy use (MMT) (Kissock, 2010)

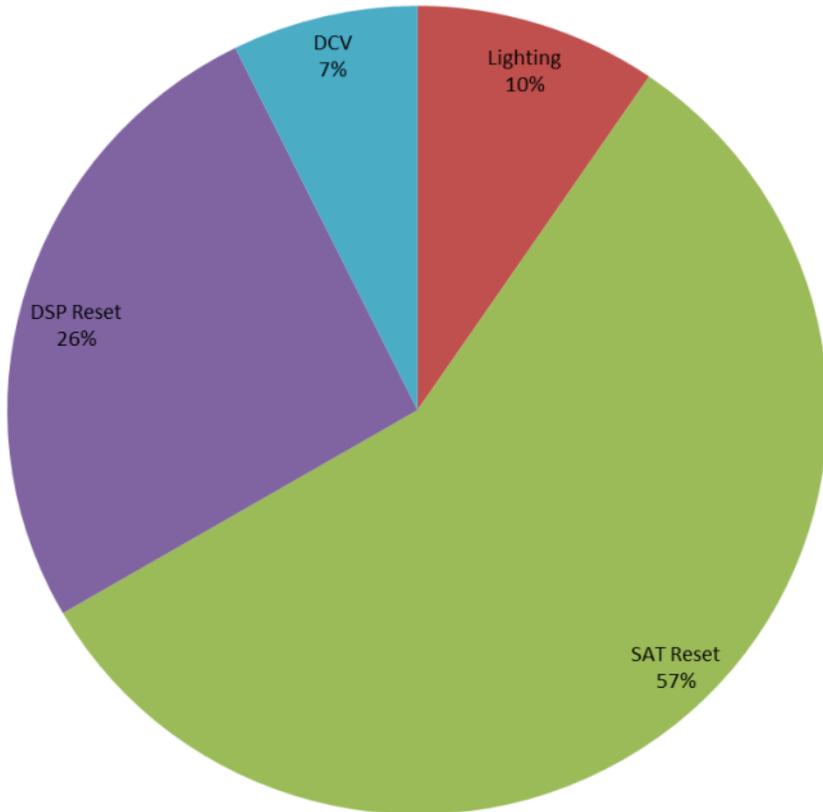
**Building #1 (saves 11% of annual energy use)**

Note: Lighting- lighting related retrofits including day lighting harvest, occupancy sensor based control, etc.; DCV- Demand Control Ventilation; DSP- Duct Static Pressure Reset; SAT Reset- Supply Air Temperature Reset;

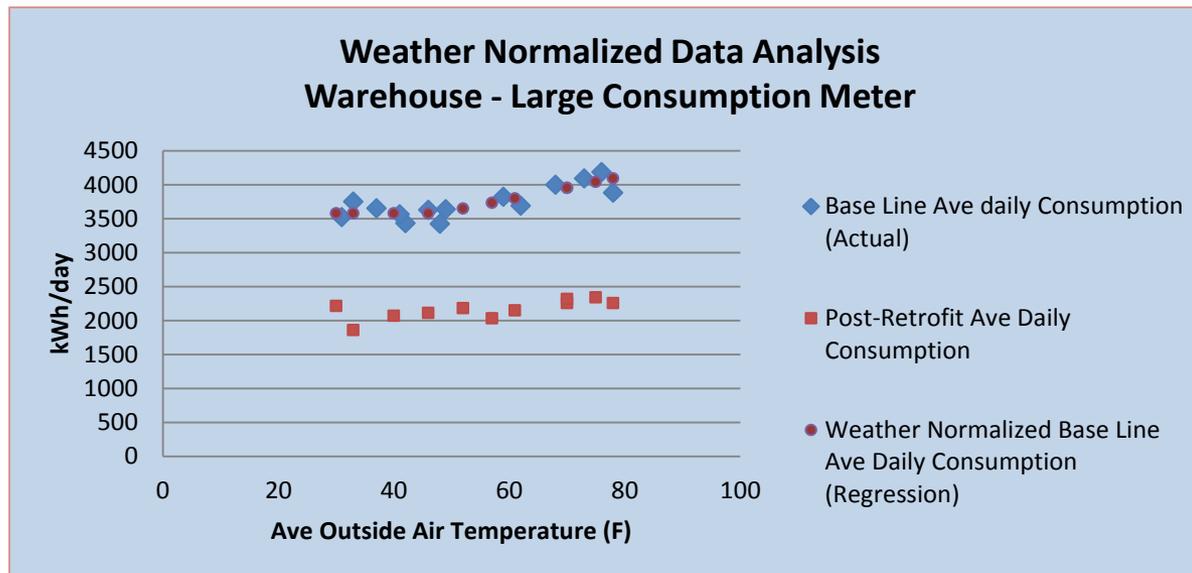
- Two electric accounts serve the warehouse space (387,500)
- Total electric usage for base line year was: 1,783,000 kWh
- One electric account showed relationship between outside air temperature and building energy use; other electric account did not show this type of relationship
- Three methods were used to determine energy savings:
  - Monthly year-to-year comparison based on utility billing data
  - Weather normalized base line comparison
  - Average weekday and weekend hourly loadshape comparison

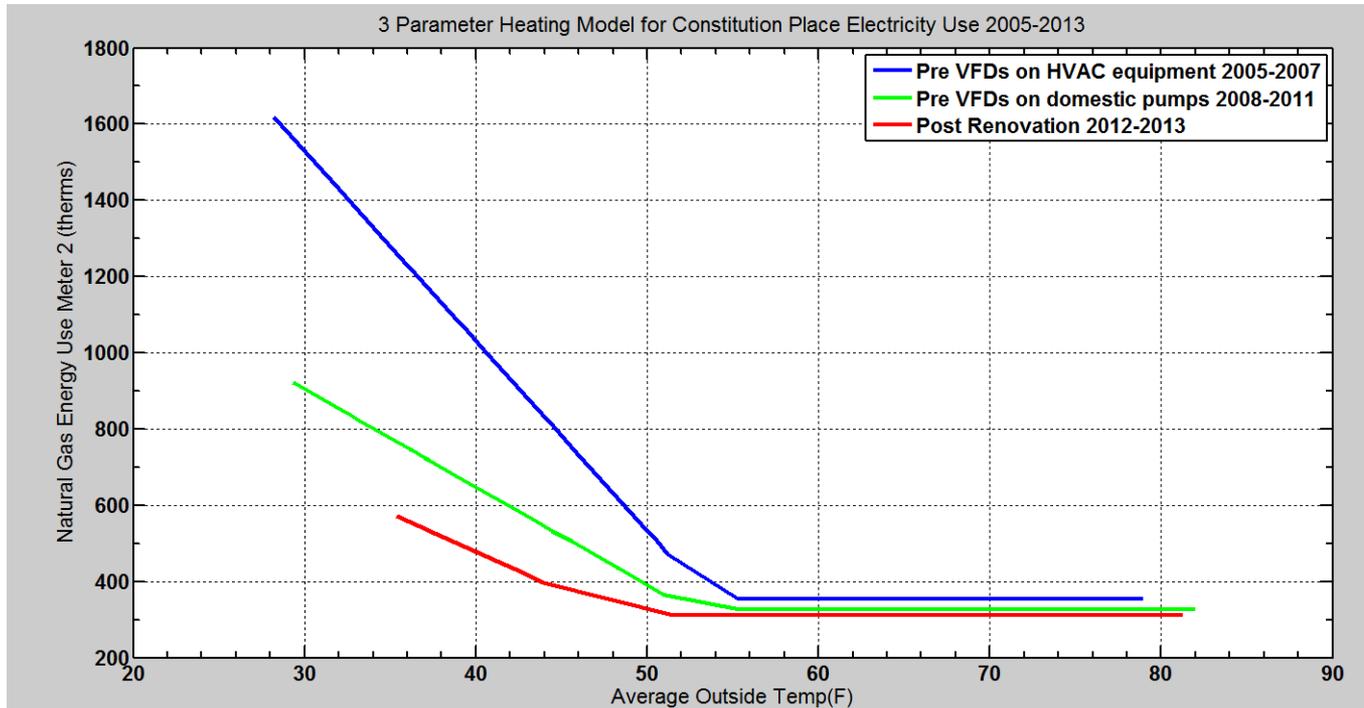
- Natural Gas Use
  - Domestic Hot Water (Meter 2)
